# Fob Filter - Fitting Instructions

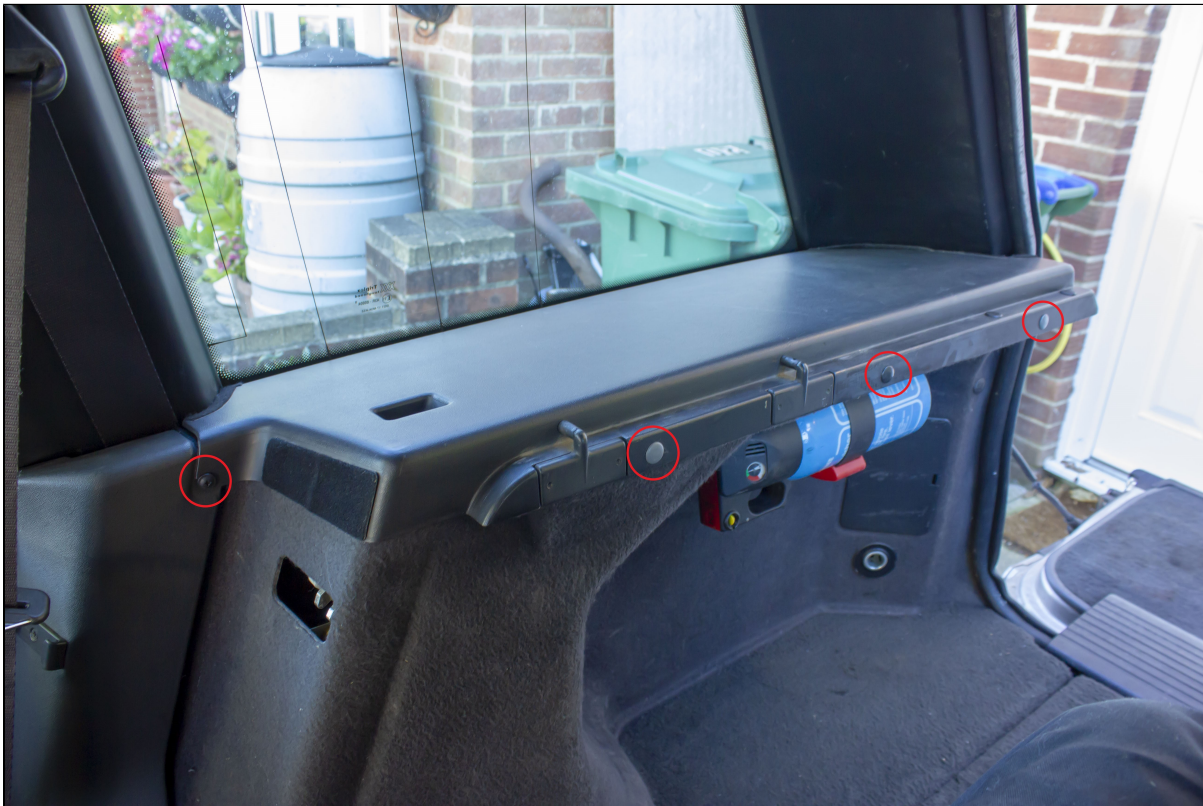
1. Fold the rear seats down - they do not need to be rolled forwards.
2. Using a trim clip removal tool or other implement, pop out the three push in clips along the edge of the trim panel, and remove the single screw as shown:

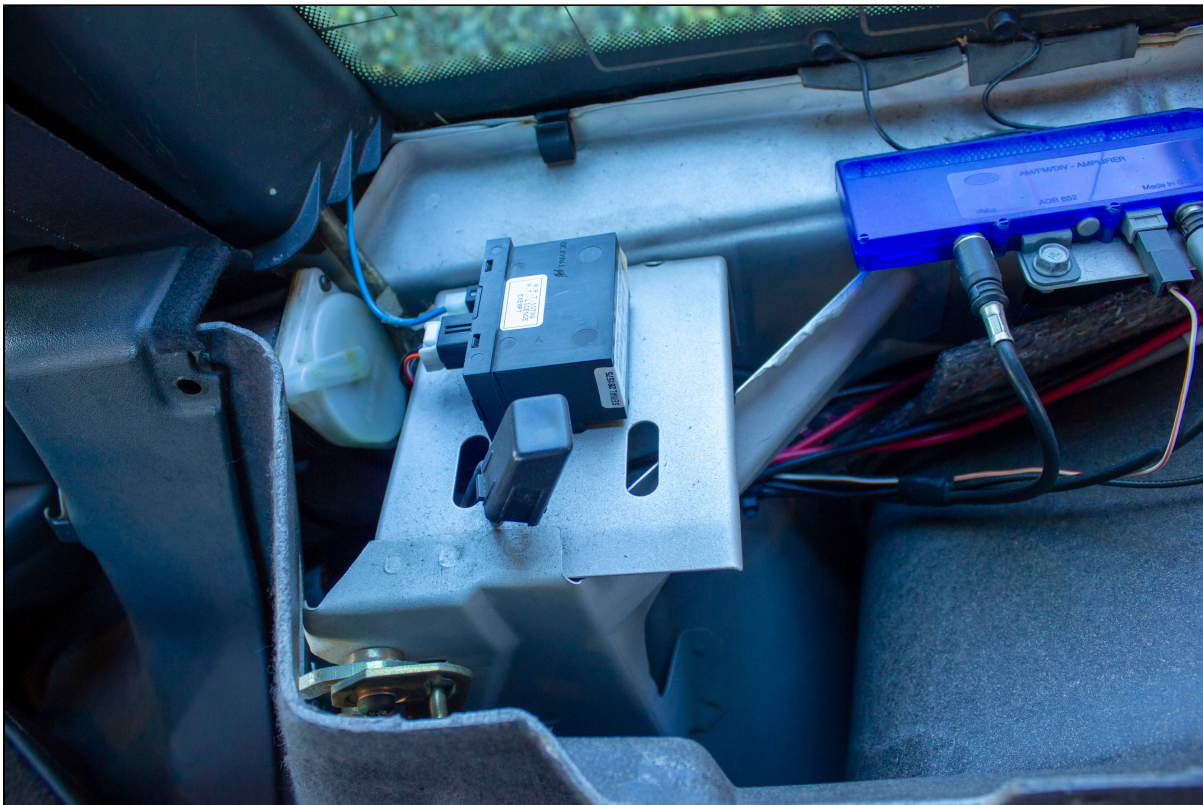
4. Set the panel to one side - you should now be able to see the receiver on top of a metal framework, it is the small black box nearest the rear seats.

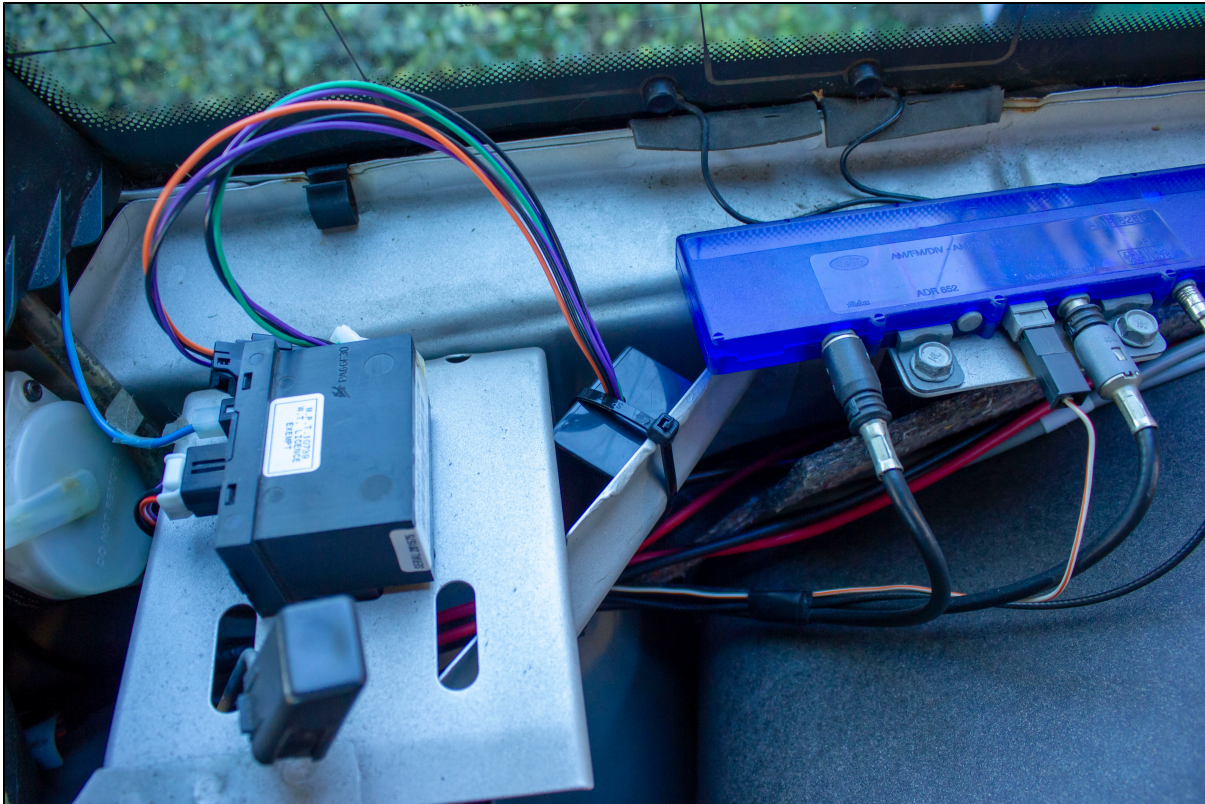
5. Position the Fob Filter unit on the inside of the supporting diagonal metalwork, and secure it in place with a cable tie.

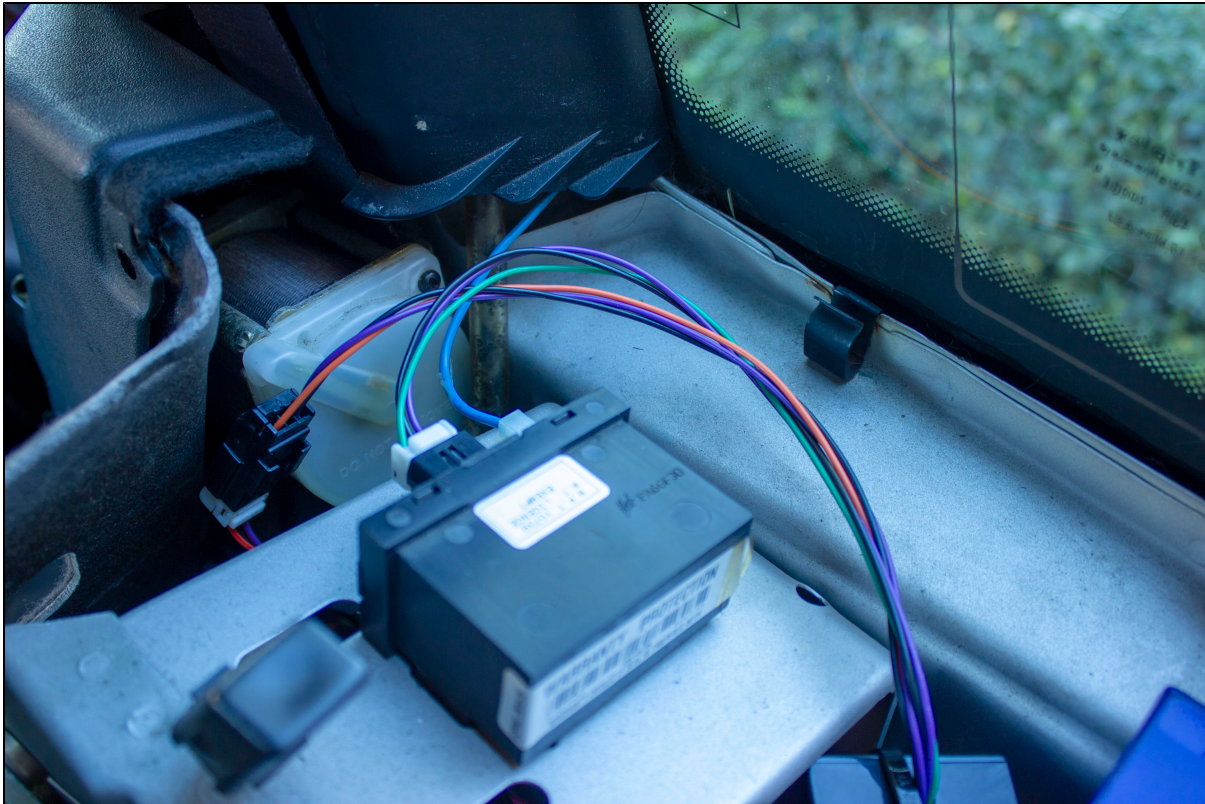
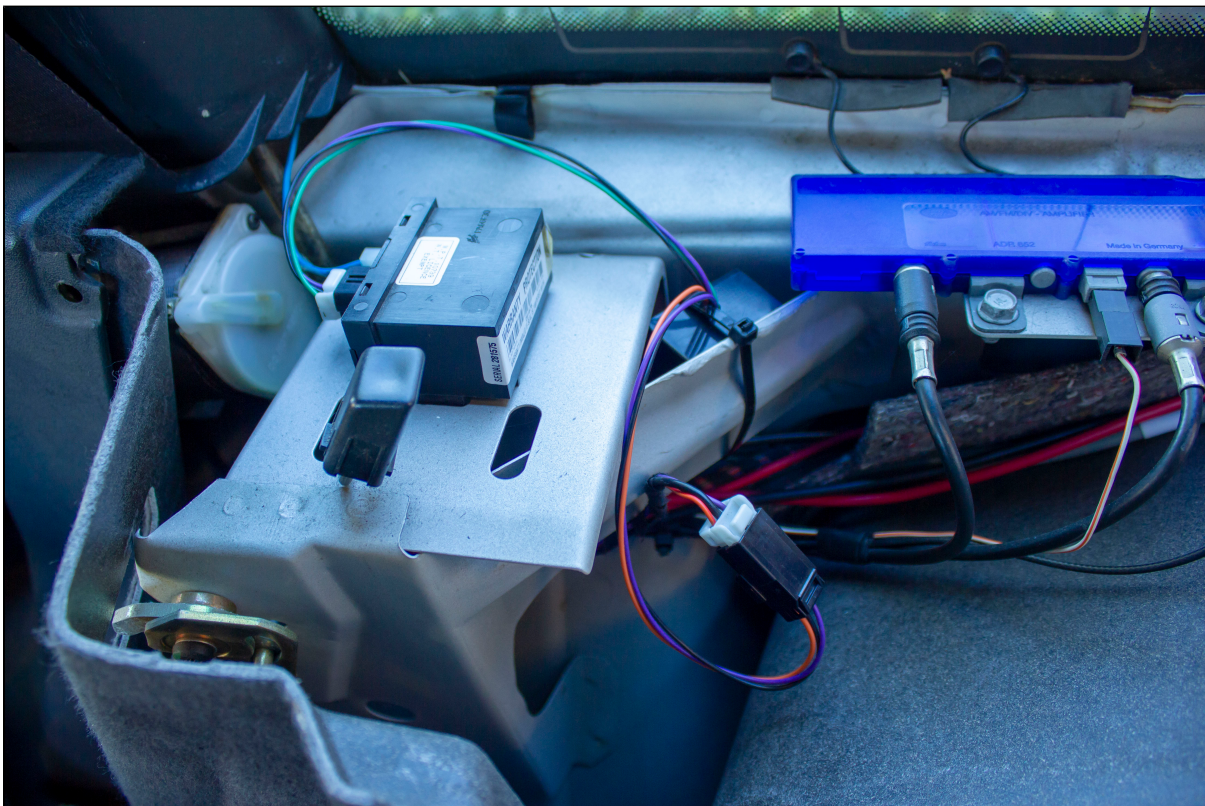
If the blue wire is currently disconnected, reconnect it to the receiver. The cables can be routed either both behind the original receiver, or with one cable around the receiver, and one cable underneath the framework. So long as the cables are not going to be caught by the seat belt mechanism or rear seat release, you can route them as you choose:

6. Unplug the white three pin connector from the receiver by depressing the tab and pulling the connector body - do not pull on the wires! A flat bladed screwdriver or similar implement may be used to help lever the plug out from the receiver while depressing the tab - they can be somewhat stiff. Connect this into the black socket on the filter unit, and connect its own white plug back into the original receiver.
