Fob Filter - Fitting Instructions

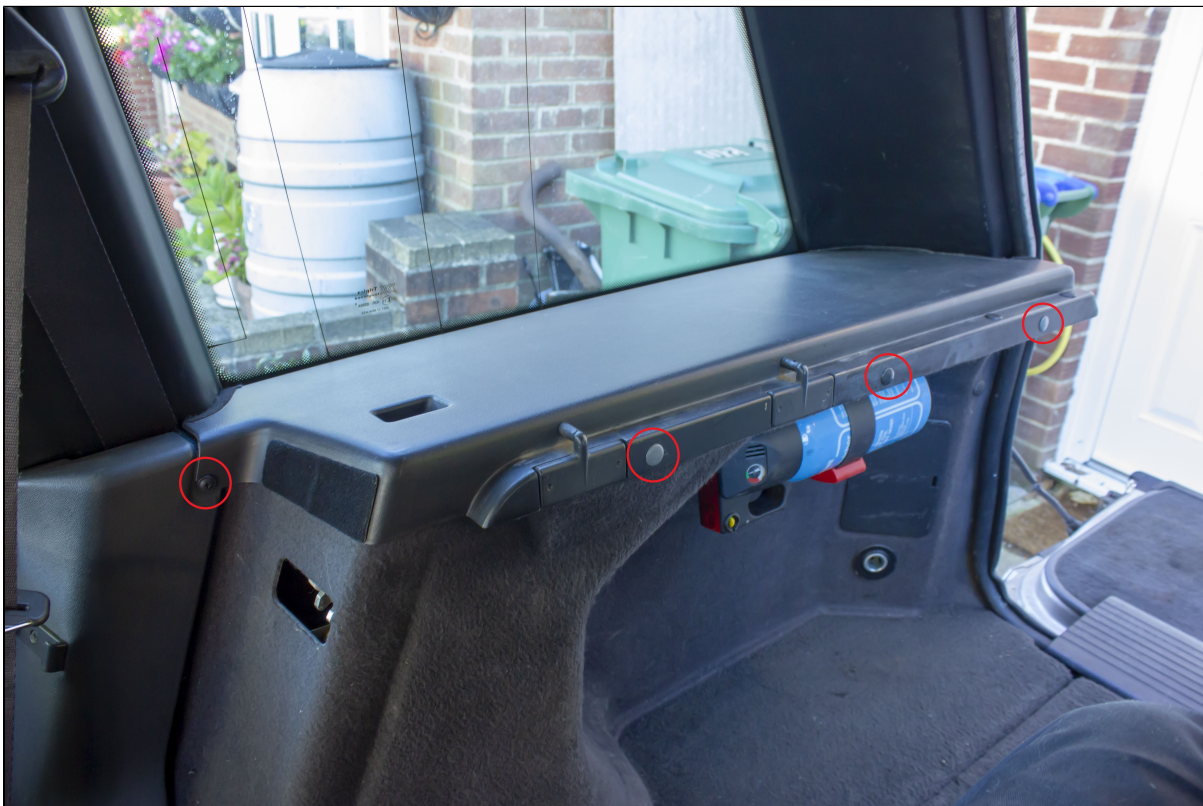
1. Fold the rear seats down - they do not need to be rolled forwards.
2. Using a trim clip removal tool or other implement, pop out the three push in clips along the edge of the trim panel, and remove the single screw as shown:

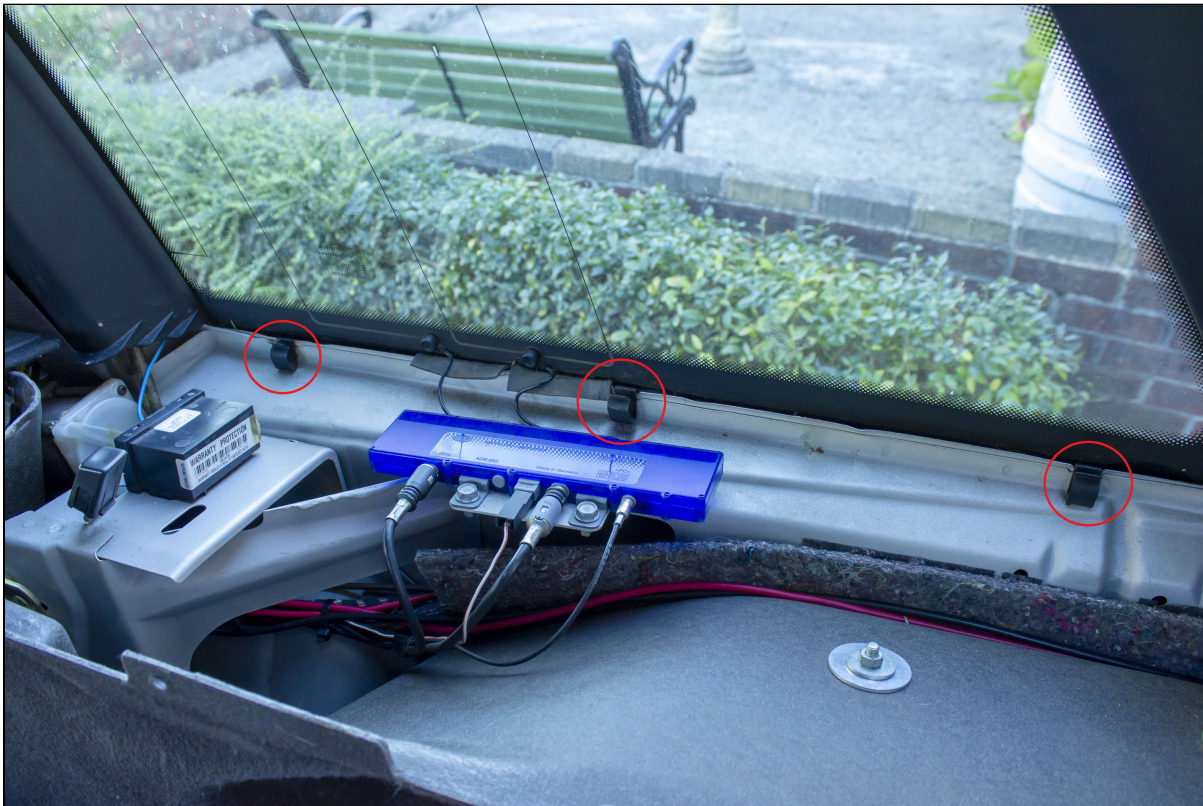
Depending on your model, the blue box in the picture below may not look the same. This is the AM/FM antenna amplifier for the diversity system, it can be ignored.

3. Lift the panel starting from the rear seat end. It will need to be levered upwards with moderate force - there are three metal clips along the window edge that the panel should release itself from.

These metal clips often become detached from the bodywork - this is not a problem, though try to prevent them falling down into the cavity. They will need to be pushed back onto the bodywork before the panel is refitted.

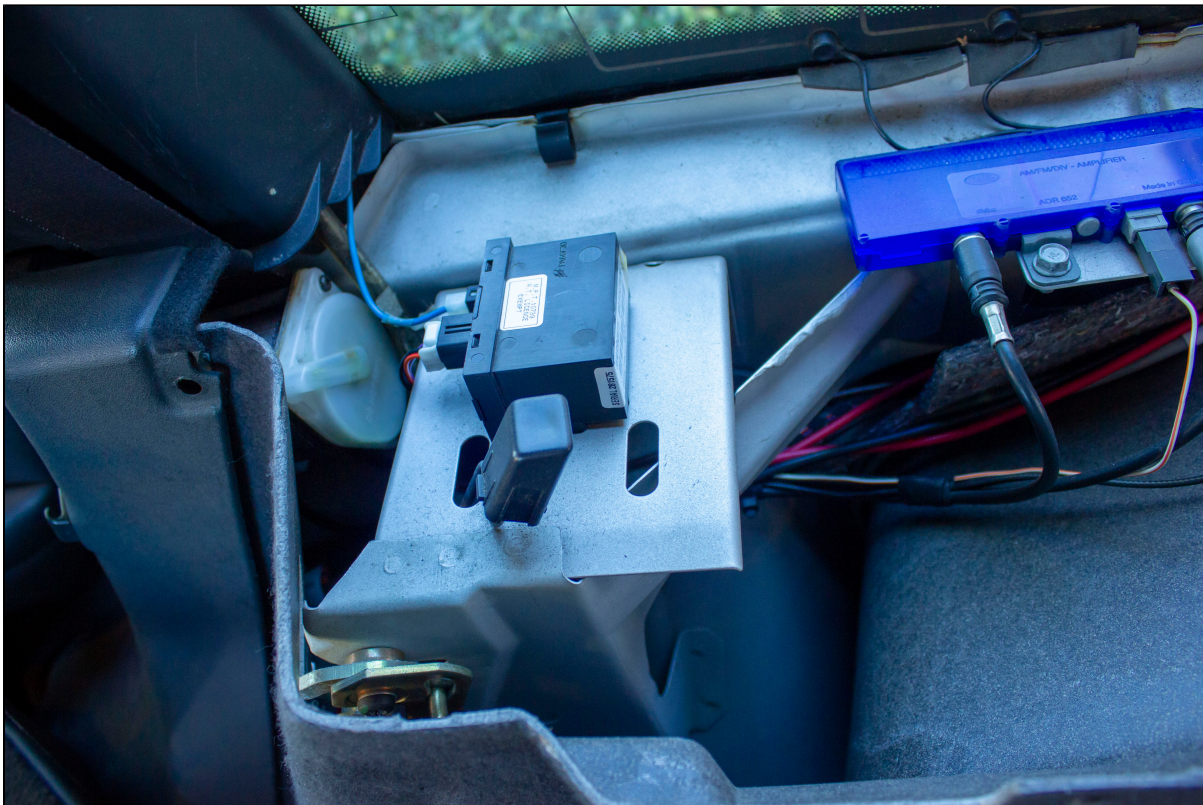
4. Set the panel to one side - you should now be able to see the receiver on top of a metal framework, it is the small black box nearest the rear seats.

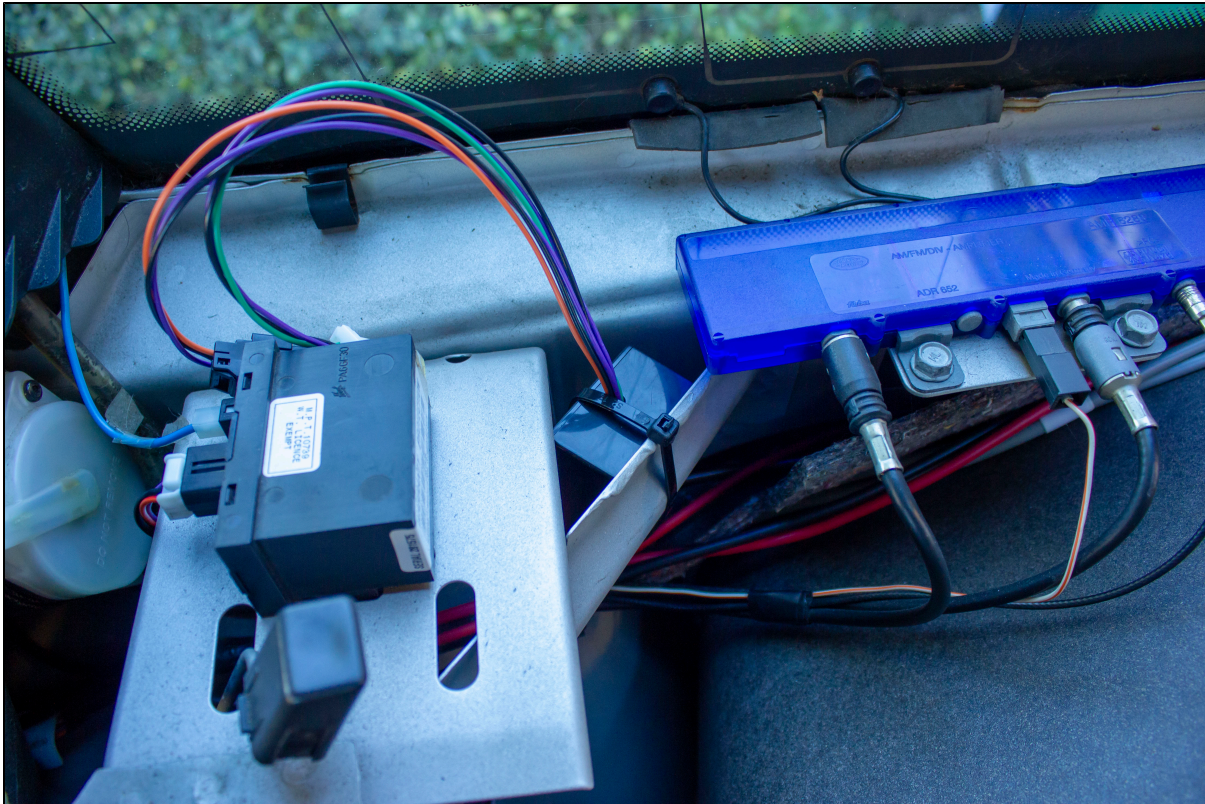
5. Position the Fob Filter unit on the inside of the supporting diagonal metalwork, and secure it in place with a cable tie.

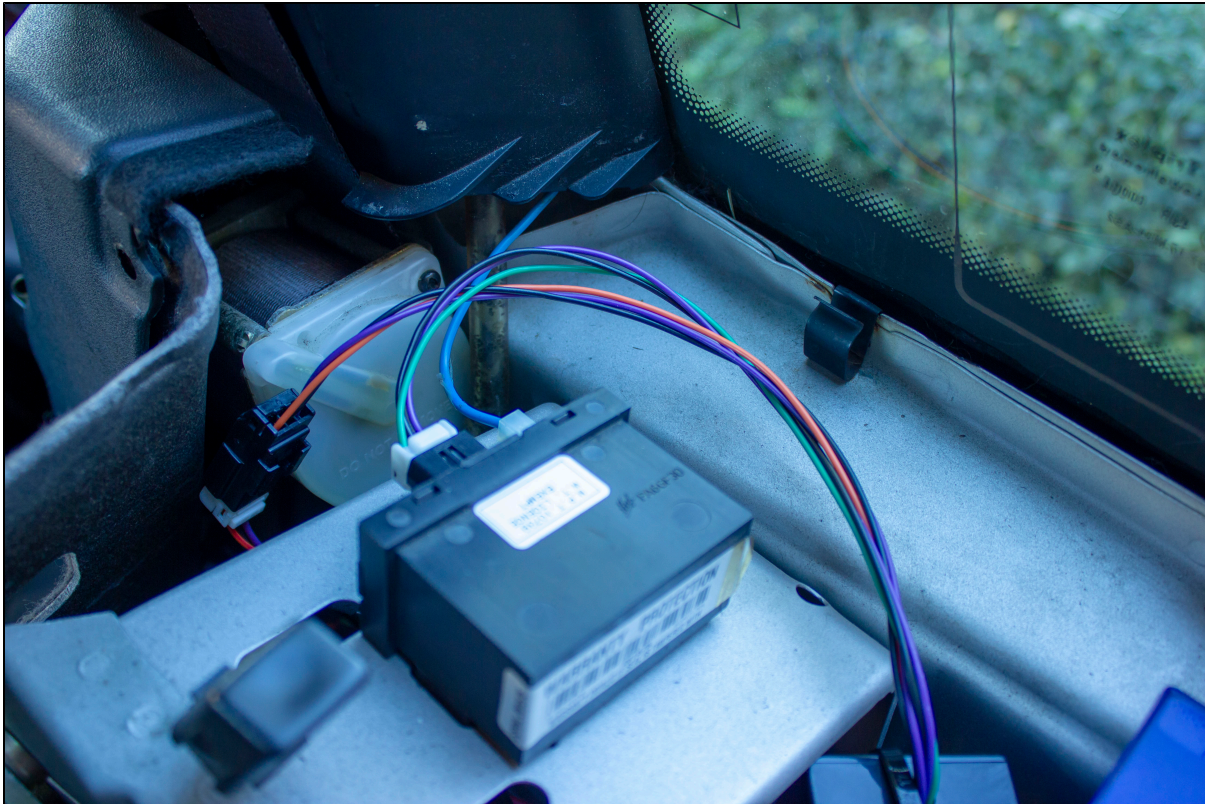
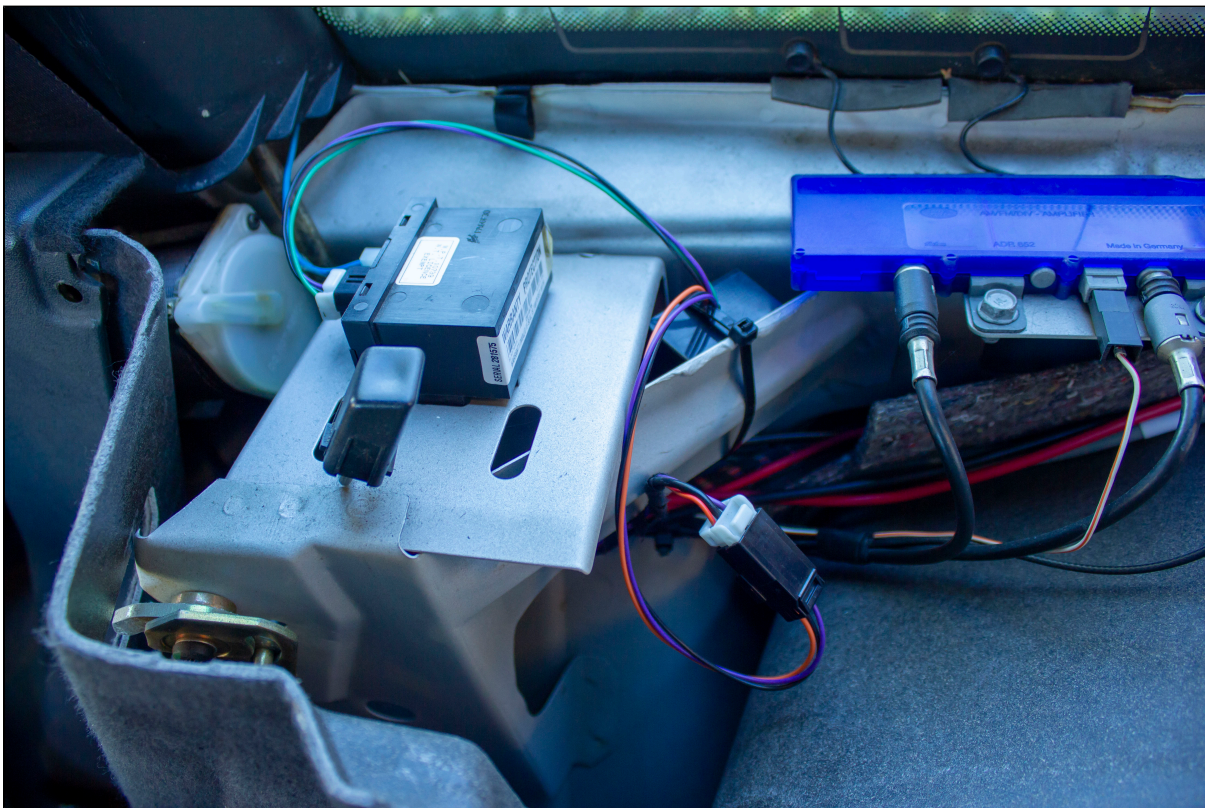
If the blue wire is currently disconnected, reconnect it to the receiver. The cables can be routed either both behind the original receiver, or with one cable around the receiver, and one cable underneath the framework. So long as the cables are not going to be caught by the seat belt mechanism or rear seat release, you can route them as you choose:

6. Unplug the white three pin connector from the receiver by depressing the tab and pulling the connector body - do not pull on the wires! A flat bladed screwdriver or similar implement may be used to help lever the plug out from the receiver while depressing the tab - they can be somewhat stiff. Connect this into the black socket on the filter unit, and connect its own white plug back into the original receiver.
